Grangemouth Flood Protection Scheme

Technical Note for Cell 2 - Dalgrain Road Area

B2386100-JEC-S4-C02-ZZZ-TN-C-0001| P03

Falkirk Council

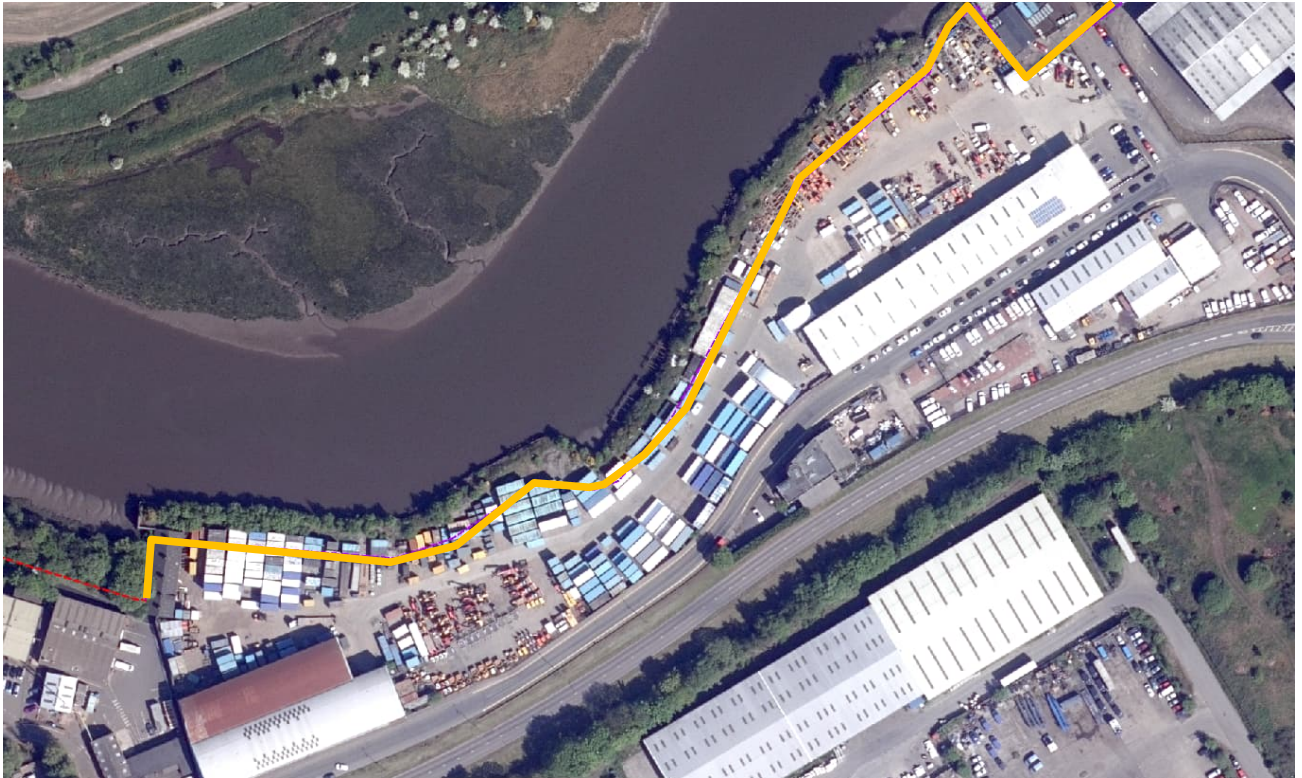
Figure 19 flood defence alignment through Jarvie Plant Yard

Where practical the flood defence should be set back from the bank top, to reduce the potential exposure to contaminated ground, The existing riverbank would need to be monitored for erosion over the design life of the flood defences to ensure the flood wall is not undermined should significant erosion occur. The design team have used a worst-case scenario (whereby the existing bank has failed) to determine the pile length and ensure the flood wall would still be structurally sound in the event the existing bank fails. Aligning the flood wall ~5m from landward toe of existing bund, means the wall is completely independent from the existing bank and out-with the slope failure envelope. Option C1, would be the fastest to construct, but would require a 5m strip of land in the Jarvie Plant yard to be permanently lost. Options A and B are likely to have a greater impact on the Jarvie Plant yard whilst construction works are ongoing. Option A would reduce the permanent footprint of the Jarvie Plant, where as option B would allow the current yard area to be maintained. Options D and E do not alter the Jarvie Plant yard.
